Finishing Standards

Minimum Standards External Concrete Finish

The external shell of all Plungie pools are finished and delivered to a Class 2 concrete standard. (AS 3610-1995)

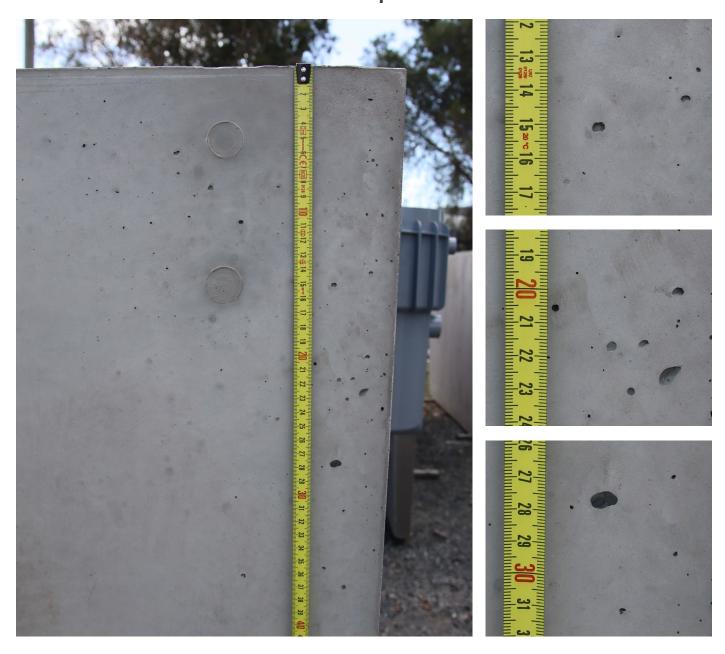
BLOWHOLES

Blowholes (sometimes called bug holes) are individual rounded or irregular cavities that are formed against the formwork in the manufacturing process. Small blowholes tend to be approximately hemispherical in shape with no pattern to where they are located on the external of our pool shells.

The following images show what can be reasonably expected for size, frequency and location of blowholes on each Plungie and constitute a Class 2 finish. .

Note: The bubbles that show on the underside surfaces of stairs etc are normal and not visible in most installations. These are unavoidable and factored into the overall structure of the pool.

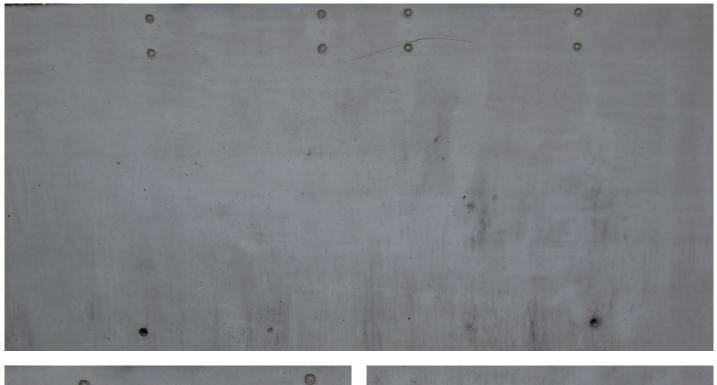
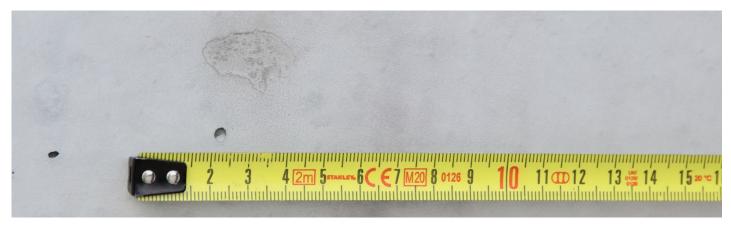
SURFACE DETAILS

Some minor markings may also be present on the surface from the casting process or following rectification work for blowholes that were deemed larger than a Class 2 finish. These markings are superficial only and do not present a structural risk.

The following images show what can be reasonably expected on each Plungie and still constitute a Class 2 finish.

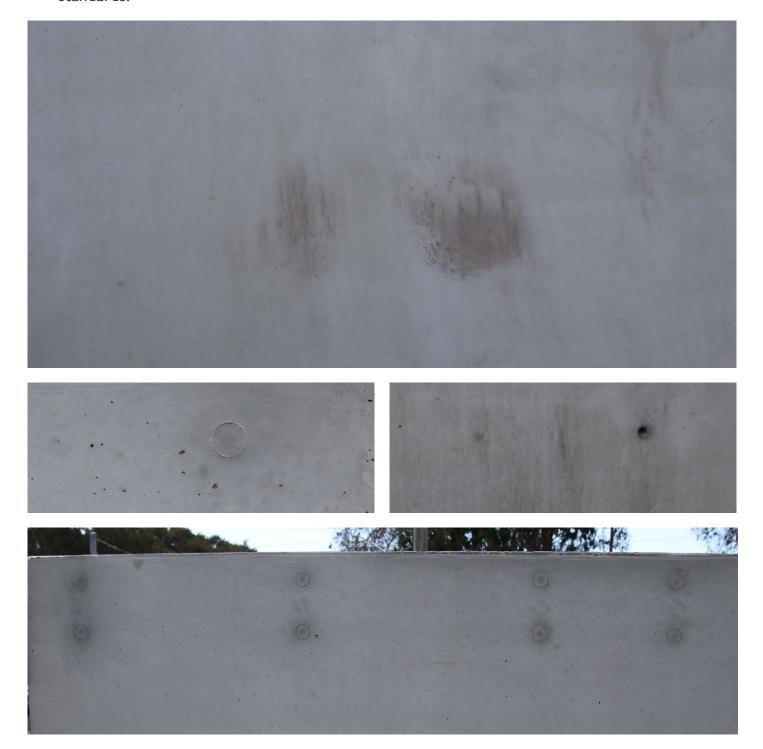
COLOUR CONSISTENCY

As with all concrete casting, variations in markings and the colour of the outer concrete can also be expected. As well as colouring of the concrete itself, some transfer of colour can occur from the moulding process leaving a light reddish/rust tinge. The below imagery shows the shades that can be expected while remaining within the set standards.

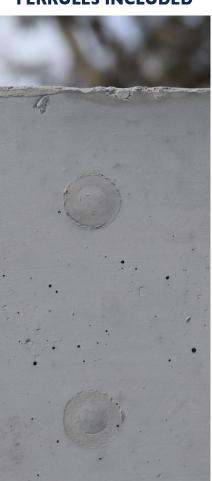
NO FENCING FERRULES INCLUDED

Our Plungie's are designed and engineered to be used either with or without fencing and dowelling ferrules near the top edge of the pool. These are installed at the time of casting and cannot be retrofitted. Some pools may be manufactured with evidence on the surface of where these ferrules would be installed. They pose no issue to the finish and structural integrity of the pool.

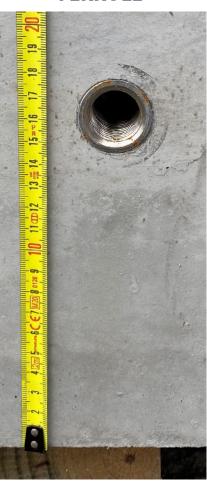
LIFTING FERRULE

Lifting ferrules (M20 / M24) are located on all Plungies (refer to pool specification documents for positions and lifting instructions) as requirements to be able to deliver and install each pool. Markings may be present around these points as a normal part of the transportation process.
